Western Fire Center, Inc.

Fire Resistance Testing of a
Floor/Ceiling Assembly in
Accordance with ASTM E119-
05a/UL 263: *Fire Tests of
Building Construction and
Materials*

PAC International, Inc.
7310 Smoke Ranch Road, Suite E
Las Vegas, Nevada 89128

WFCi Report #07083

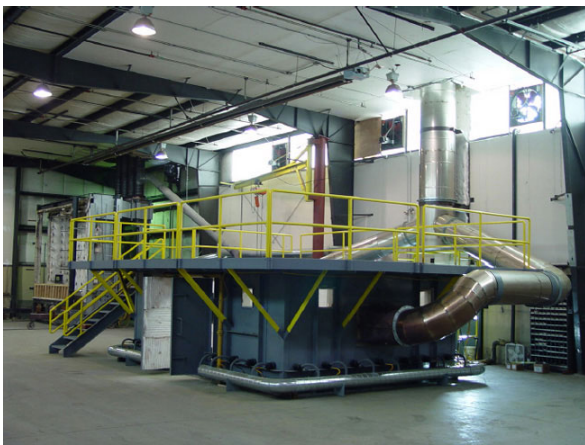
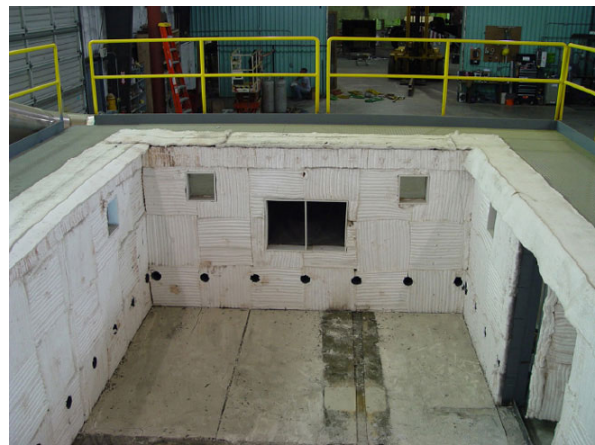
Figure 1: Large-Scale Horizontal Furnace Front View

Figure 2: Large-Scale Horizontal Furnace Interior View

The furnace used in the test was a large-scale fire exposure apparatus (Figures 1 & 2), fueled by natural gas. The test assembly was installed onto the furnace horizontally. The exposed surface was subjected to the time-temperature curve, with temperature measurements taken inside the furnace using thermocouples connected to a computerized data acquisition system. The furnace valves are controlled based upon the average of the interior furnace temperature that is determined from these nine internal thermocouples. Windows allow viewing of the specimen surface and the taking of photographs during testing. Upon completion or early termination of a test, the main gas supply valve is closed and the specimen is extinguished, if necessary, and post-testing observations are made.

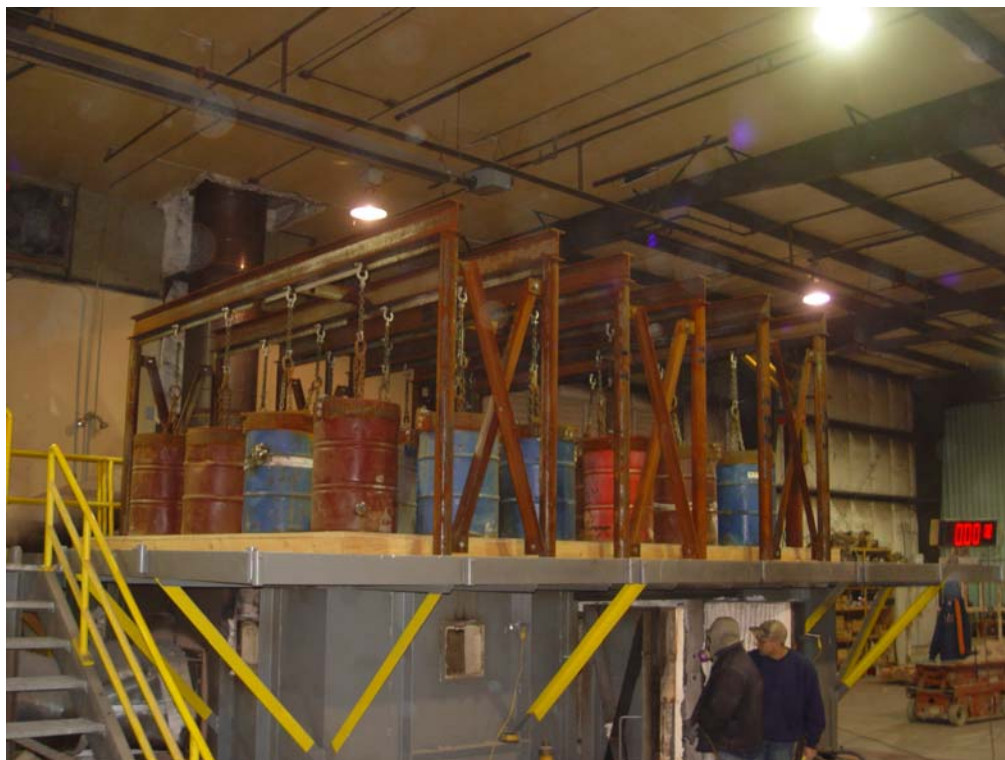
The test assembly was loaded to a live load of 65 lbs/ft² for a total combined live and dead load of 75 lbs/ft² (10 lbs/ft² dead load). The load was applied in the form of 24 weighted, evenly-spaced barrels in a 6X4 arrangement (Figure 3). The sample area was 252 ft², and the barrels were each filled with sand to weigh 682 lbs for a superimposed load of 16,368 lbs. This loading produced 100% of the maximum bending deflection at midspan.

Figure 3: Barrels Mounted on Test Assembly

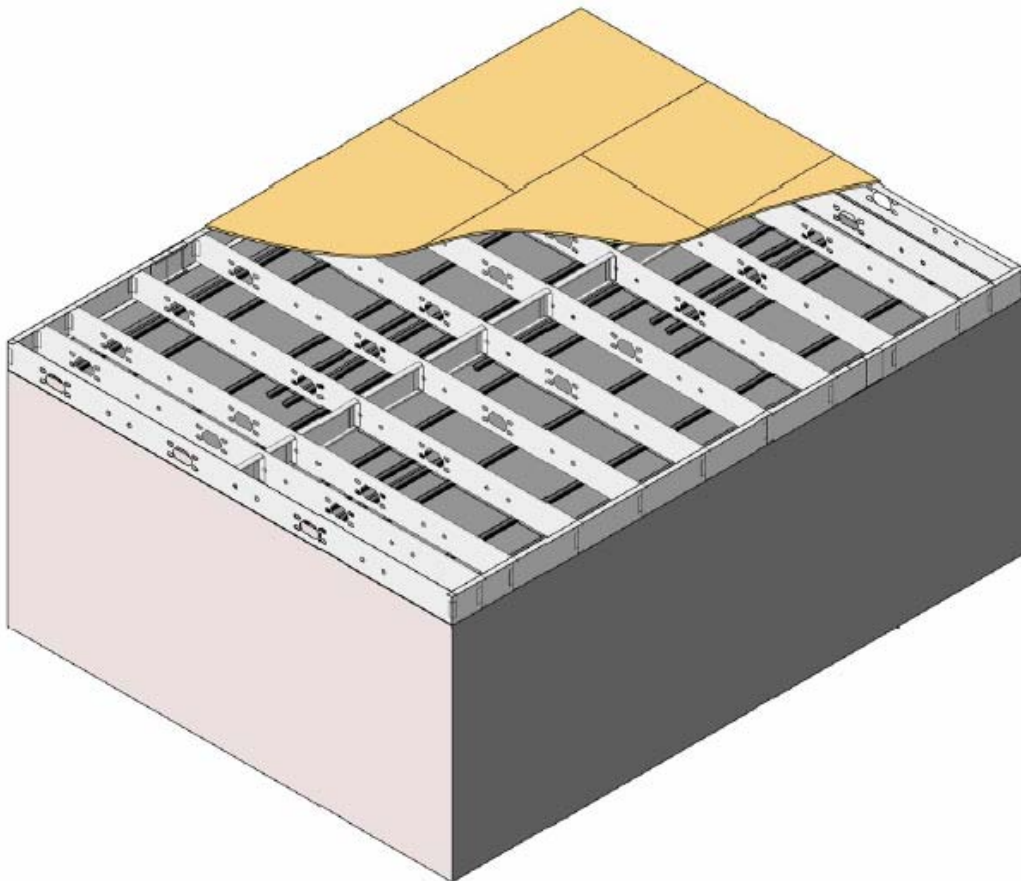
The steel joist floor/ceiling test assembly depicted in Figure 4 was constructed in accordance with the specifications detailed in Drawings A1 through A9 provided in Appendix A and the description beginning on page 7. The system was constructed in place on the WFCi large scale horizontal furnace, with structural joist elements spanning the furnace width. The outside dimensions of the completed floor/ceiling system was 14' x 18' wide, and the nominal exposed ceiling area was 12'-6" x 17'.

Figure 4. Representation of Floor/Ceiling Test Assembly

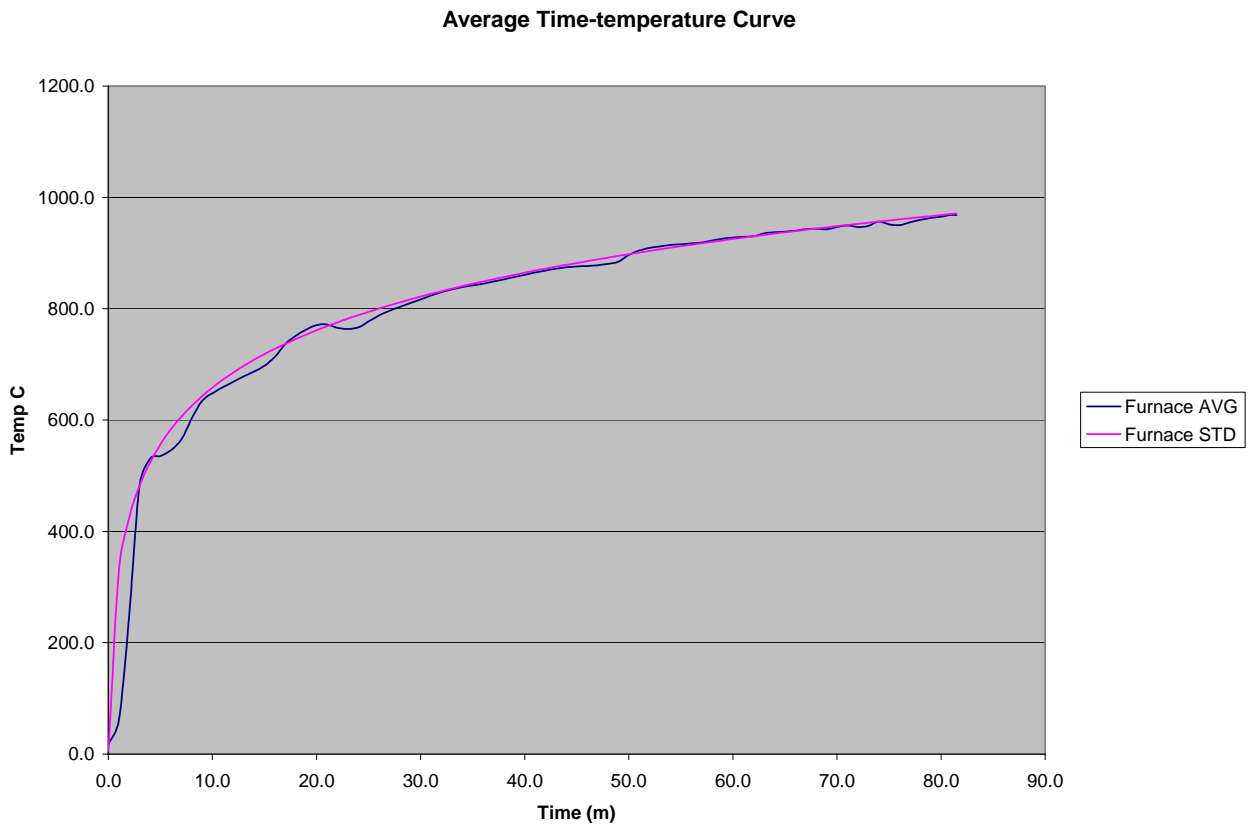
Furnace Temperatures

The area under the actual furnace curve was within 99.5% of the standard time-temperature at test termination.

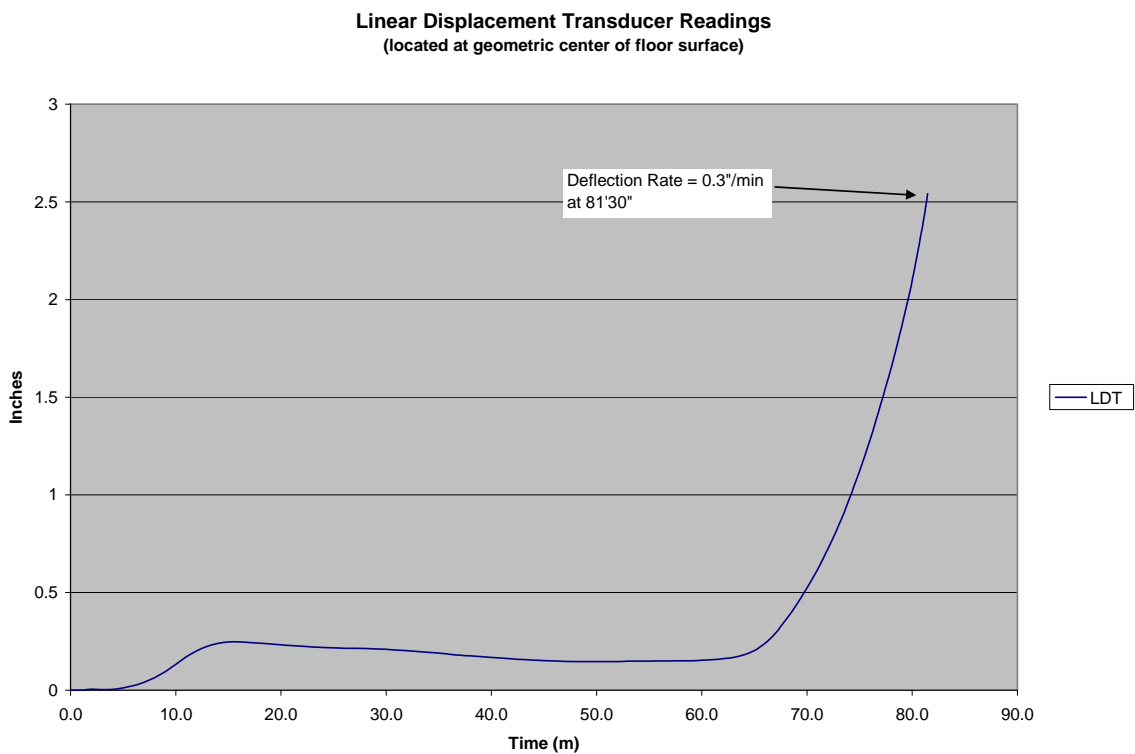
Sample Deflection

Sample deflection was measured during this test by one linear displacement transducer mounted at the center of the unexposed floor side of the test assembly.

The test was terminated at **81 minutes, 30 seconds**. The rate of deflection of the assembly was 0.3"/minute, indicating imminent load failure of the assembly.

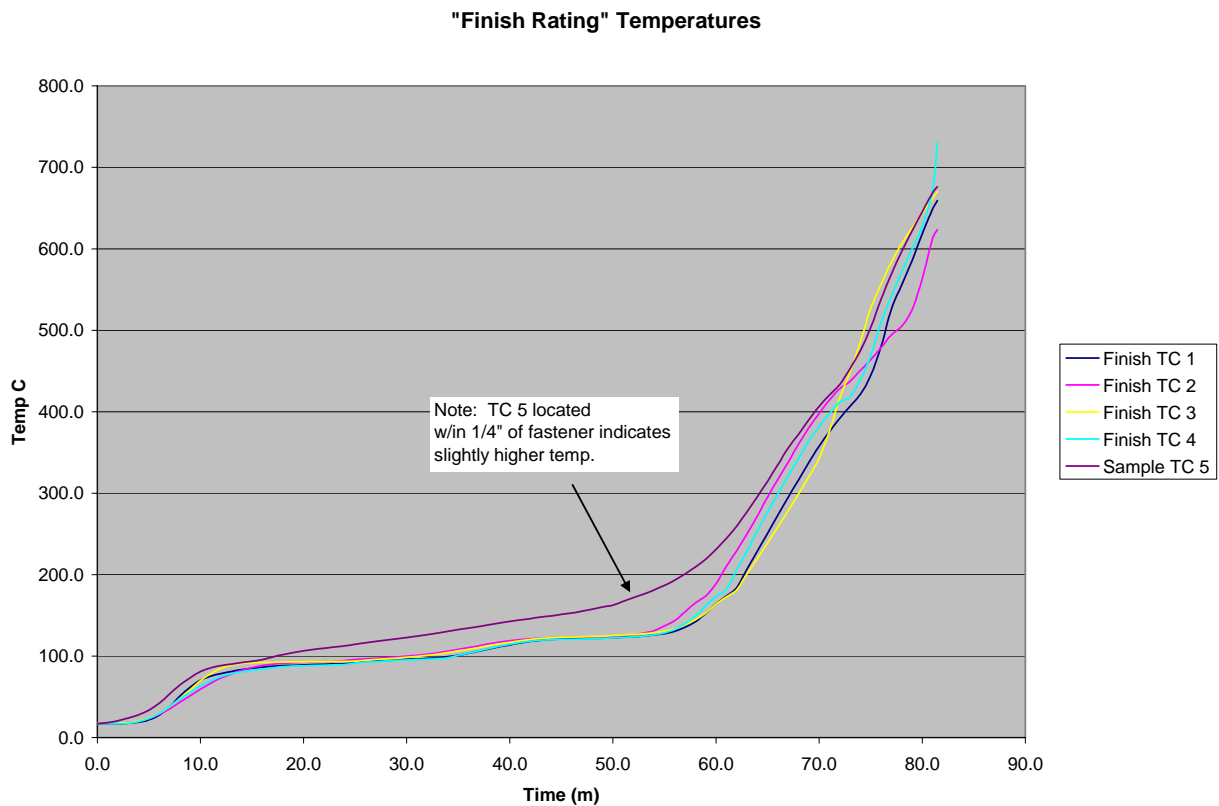
Finish Rating Temperature

Thermocouples 1-5 were placed between the undersides of furring channel and the exposed ceiling membrane at the sample center and quarter-points to determine the finish rating of the gypsum ceiling membrane. The finish rating was recorded at 58 minutes, 36 seconds when the average temperature rise of thermocouples 1-4 exceeded 139°C.

For this test, the reading from TC No. 5 was disregarded. The close (~1/4") proximity of a screw fastener to the TC 5 location caused this thermocouple to read elevated temperature readings.

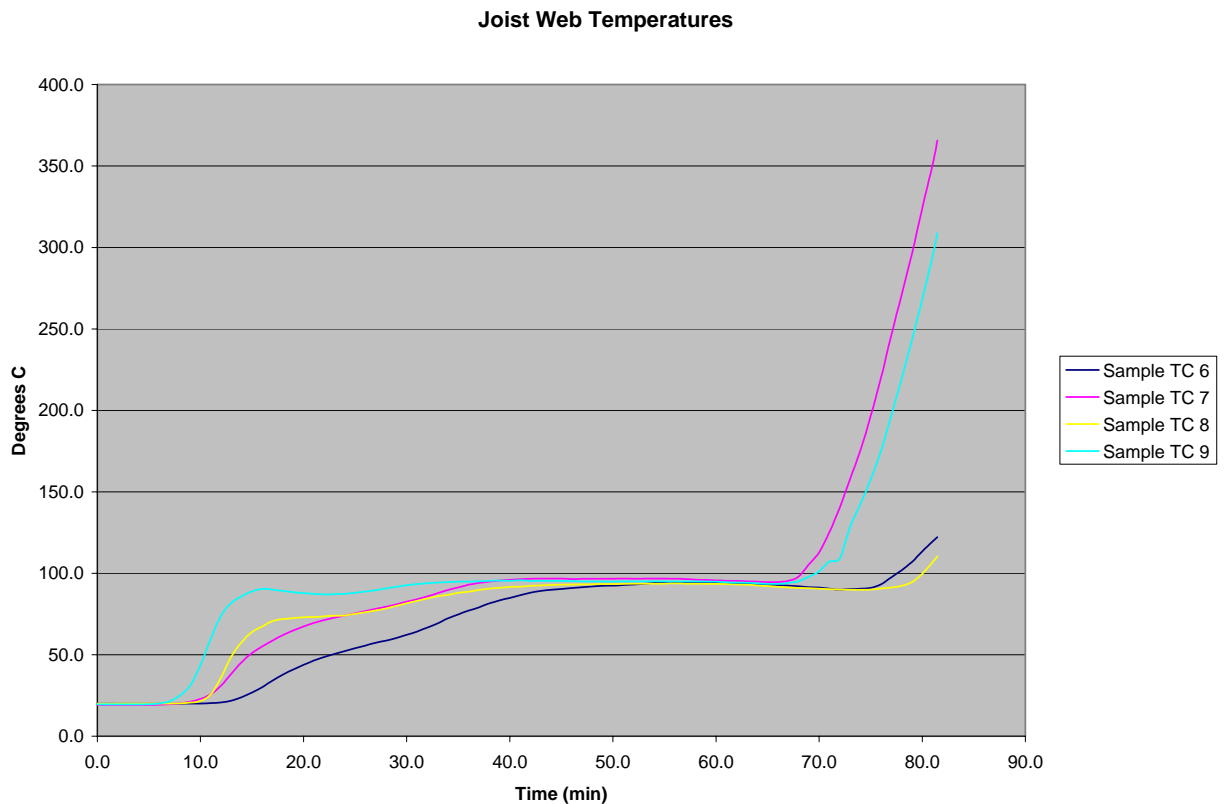
Joist Web Thermocouple Readings

Thermocouples 6-9 were welded to the hard side of the joist web of the two central joists spanning the width of the furnace. Thermocouples 6 & 8 were located on the joist web near the nominal center point of the assembly, above the insulation layer and 1" down from the plywood underlayment; TCs 7 & 9 were located 3" up from the bottom joist flange, directly below TCs 6 & 8, and within the insulation layer.

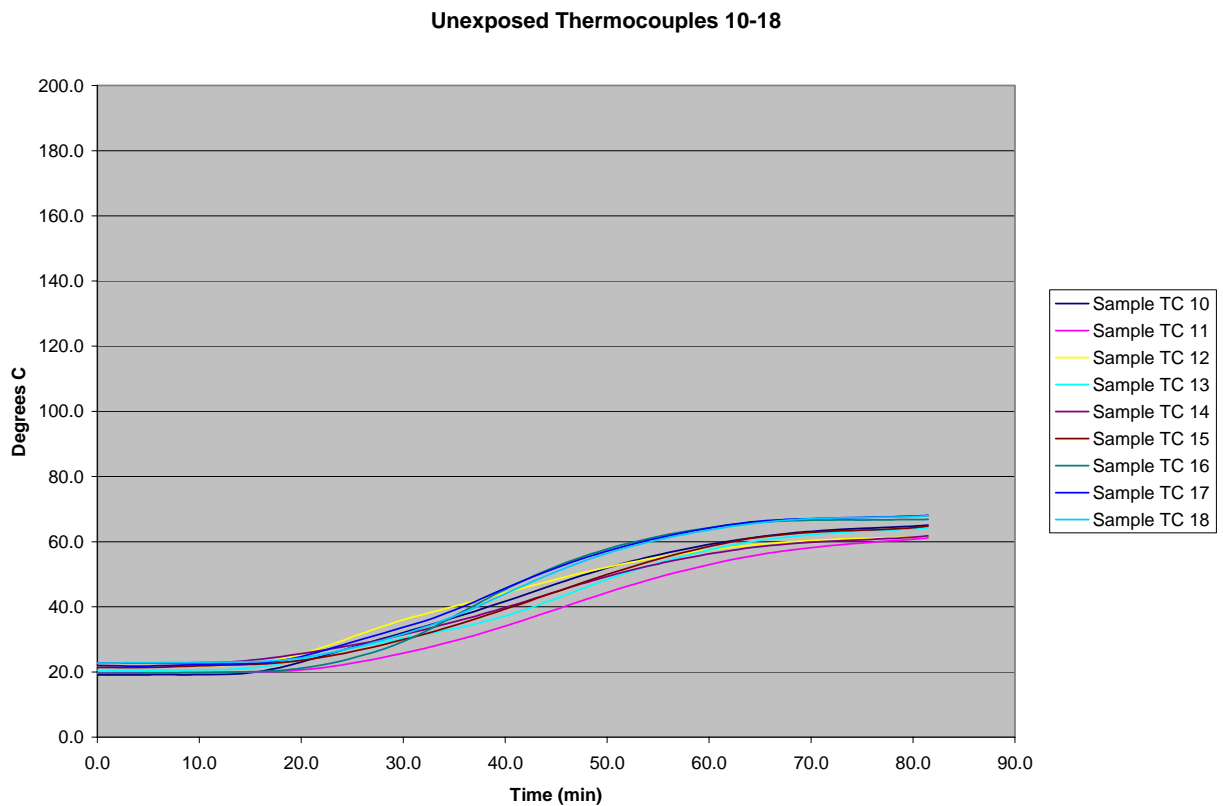
Unexposed (Floor Surface) Temperatures

Thermocouples 10-18 were placed in an evenly spaced 3X3 grid on the unexposed sample surface to monitor temperatures throughout the test. Temperatures measured on the unexposed surface were well below limiting temperature rise criteria.

Temperatures measured on the unexposed surface of the floor assembly reached a maximum of 68°C during the fire resistance test. There were no signs of the passage of heat or hot gases during the test, and the use of the cotton pad was not indicated.

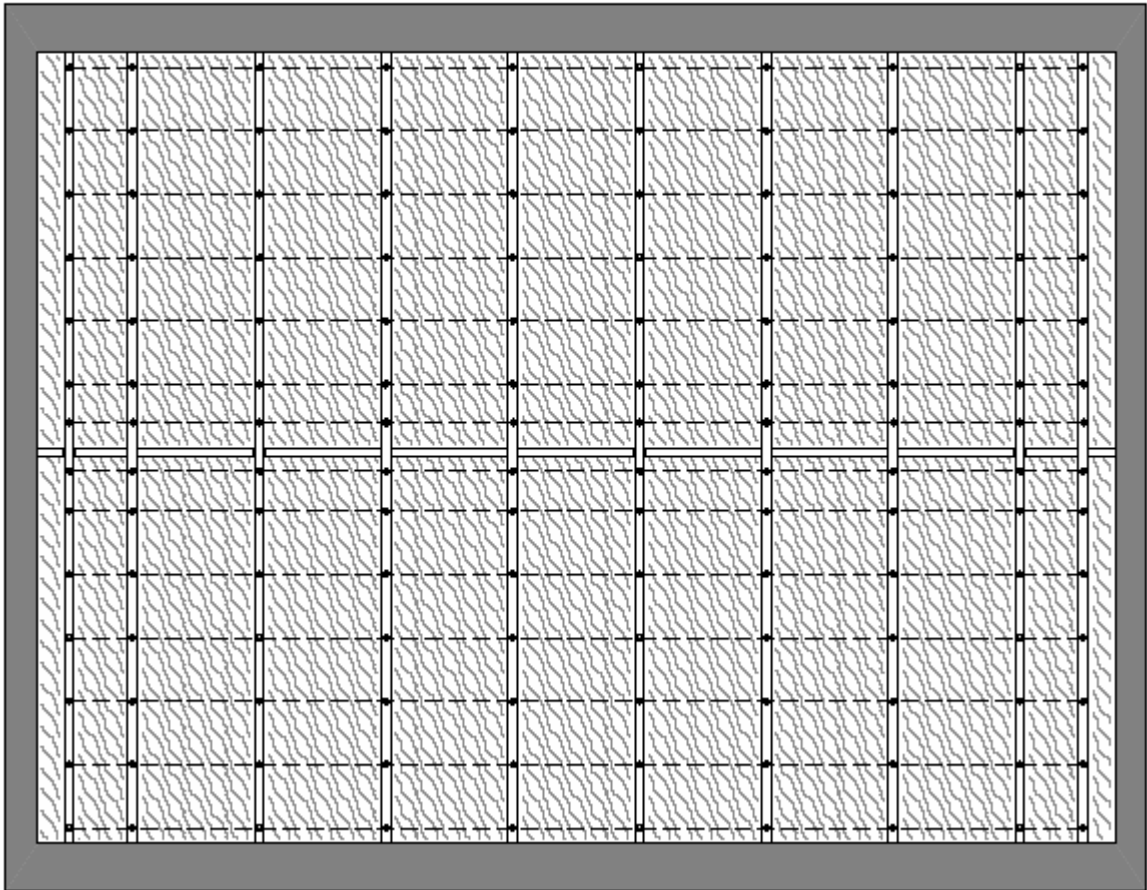
A2.1 INSULATION

INDICATES R-19 BATT INSULATION IN EACH CAVITY (SUPPORTED BY TIE WIRE)

INDICATES MINIMUM 18 GAUGE WIRE SPACED AT 12" OC. FRAMING SCREW TO BE INSTALLED IN THE LOCATIONS SHOWN BELOW. SCREW SHALL BE INSTALLED ONLY HALFWAY AND CENTERED IN EACH JOIST TO ALLOW TIE WIRE TO WRAP AROUND EACH SCREW

R-19 fiberglass batt insulation was installed in the joist cavities flush with the bottom of the joist flanges and supported by 18 ga. wire as shown in drawing A2.1.

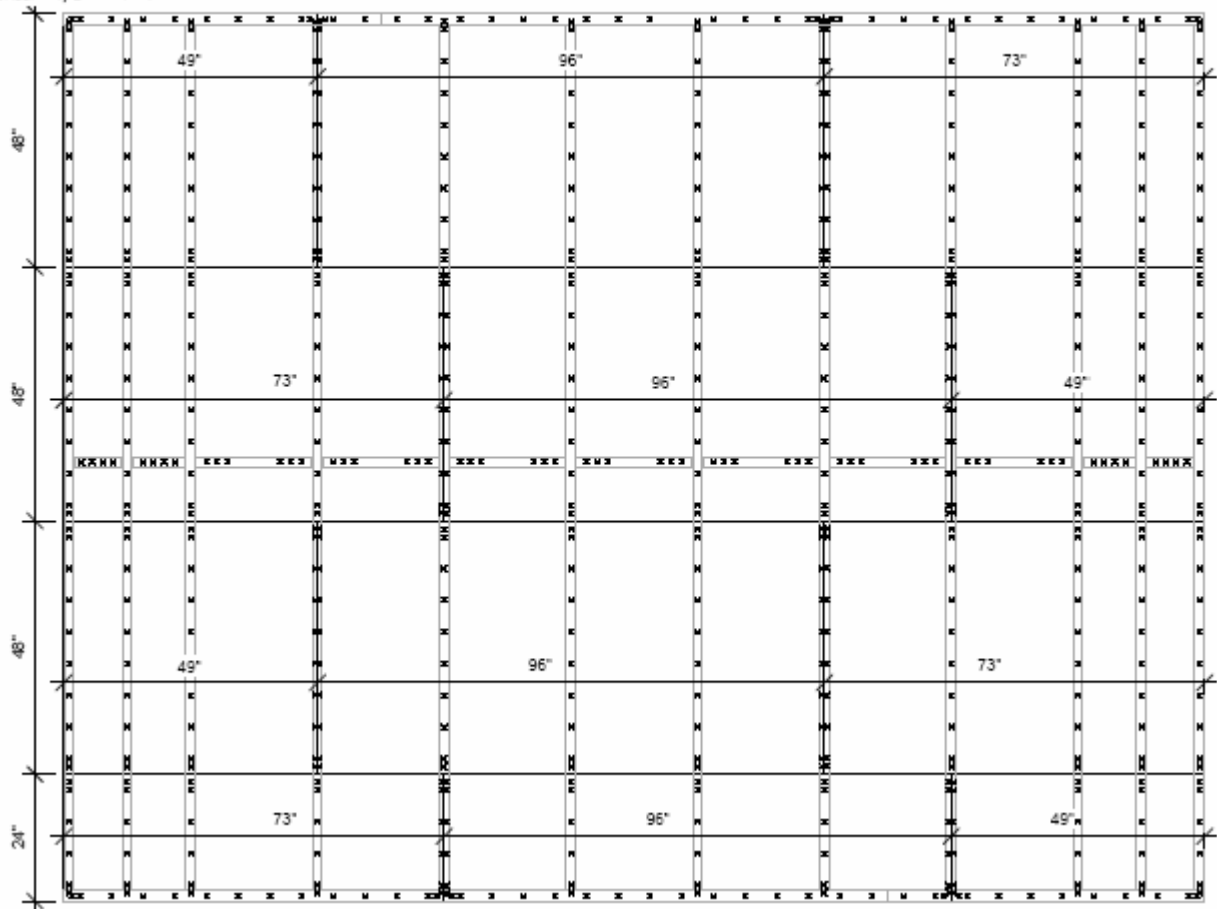
A6 TOP SHEETING LAYOUT

NOTE: ALL SCREWS ARE GRABBER BRAND ITEM NUMBER
12200FW3 FLAT HEAD WINGED DRILLER T-2 POINT #12 X 2"

The plywood subfloor was installed as shown in drawing A6. A bead of adhesive was placed on the top flange of the joists and into the grooved edge of the plywood. The subfloor was placed on the joists so that the 8 ft. length was positioned perpendicular to the joists and the ends butted, with adjacent end joints staggered 4 ft. Each piece was screw attached to the

joists at 6" o.c. and to the top flange of the structural blocking as shown in drawing A6.

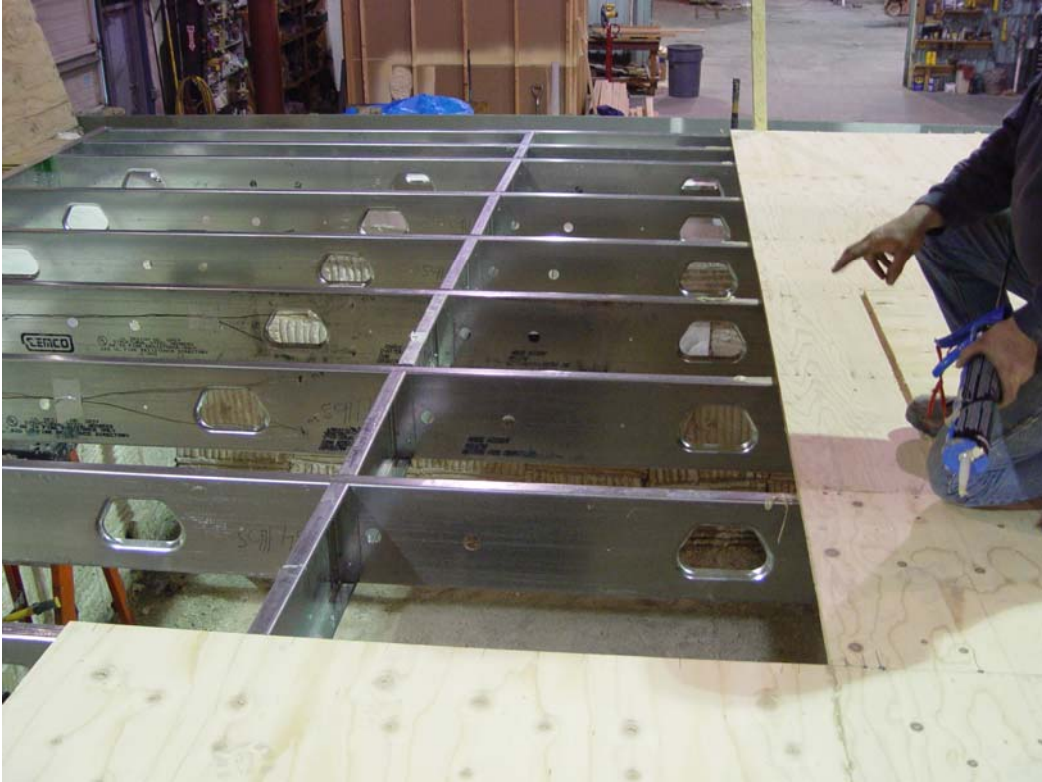
Placement of Subflooring Atop Steel Joists

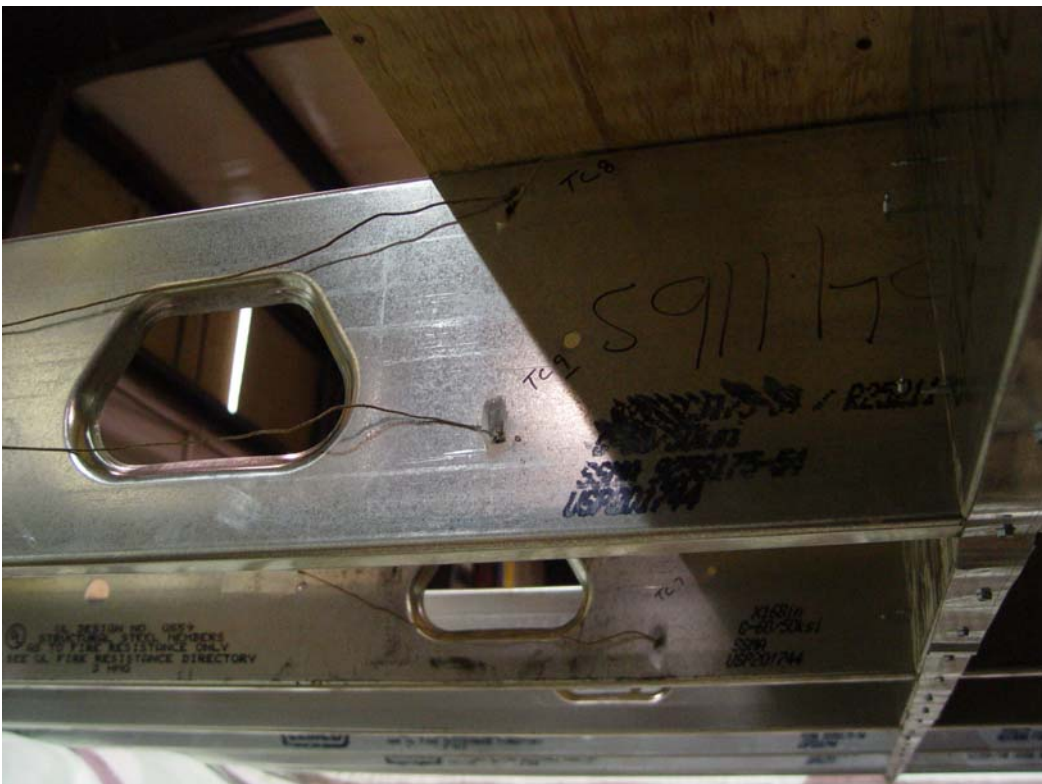
Location of Cavity Thermocouples

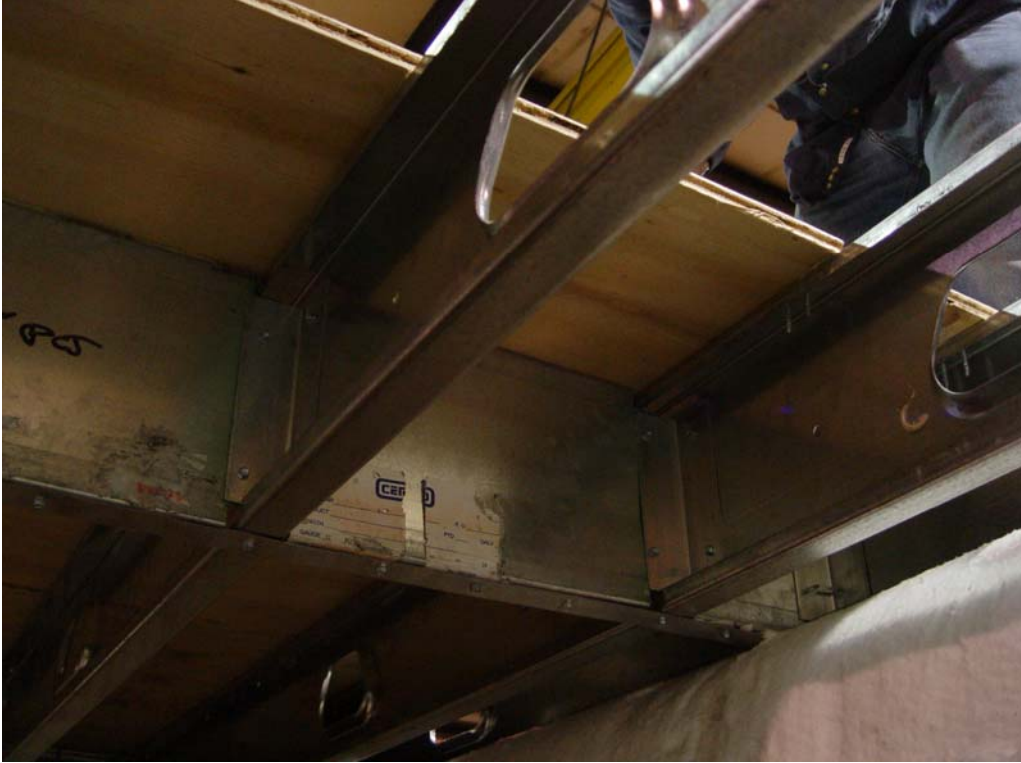
Structural Blocking

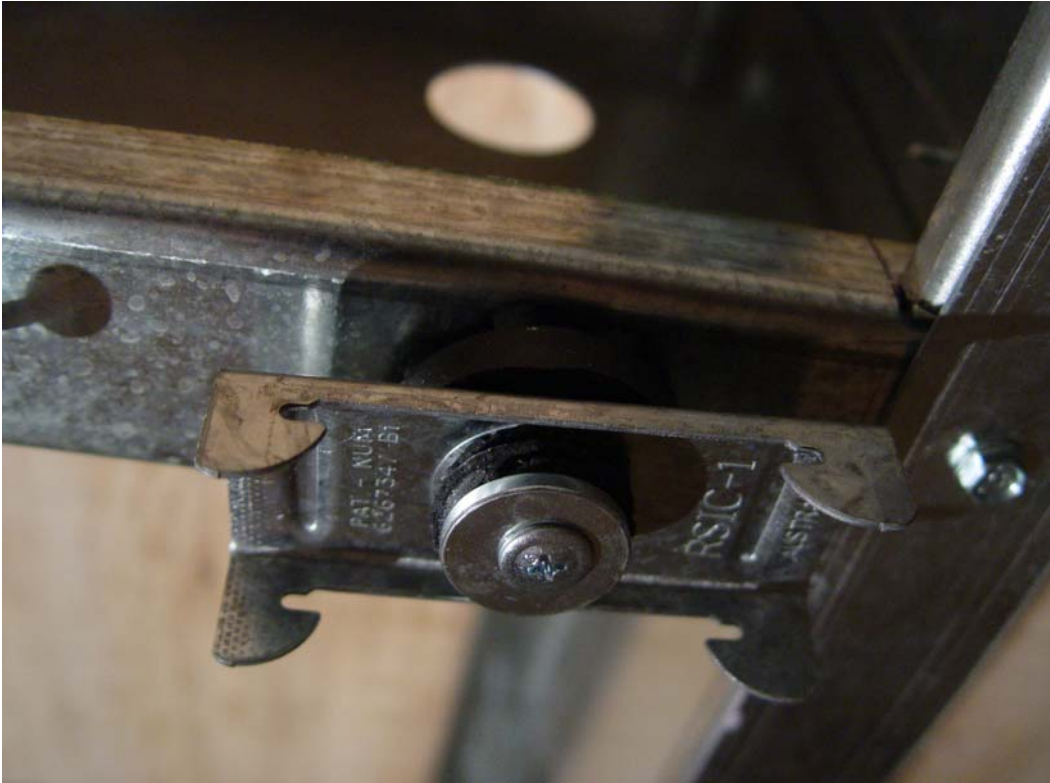
RSIC-1 Clip

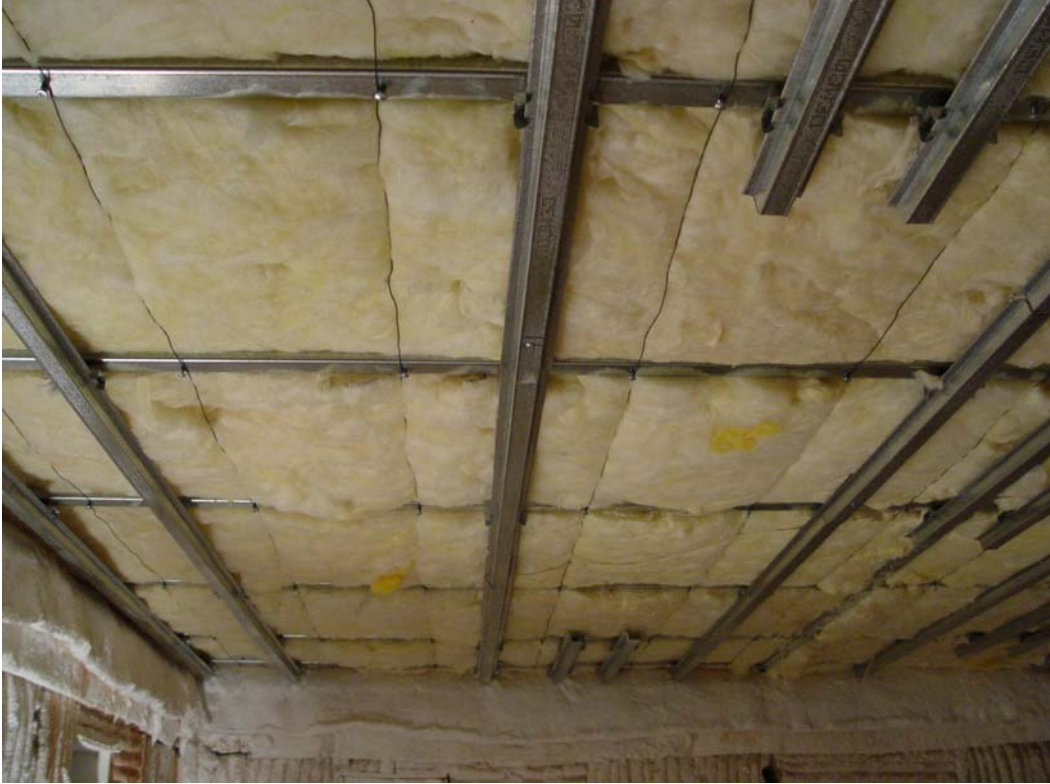
Insulation and Furring Channel Placement

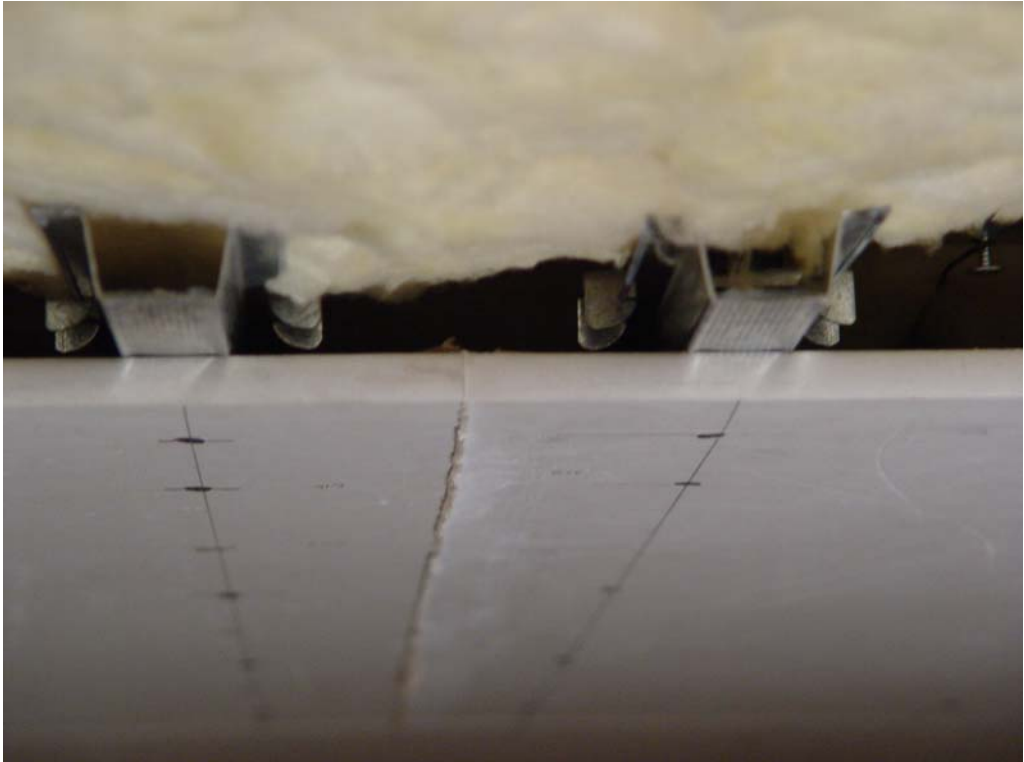
Base (Upper) Layer Butt Joint

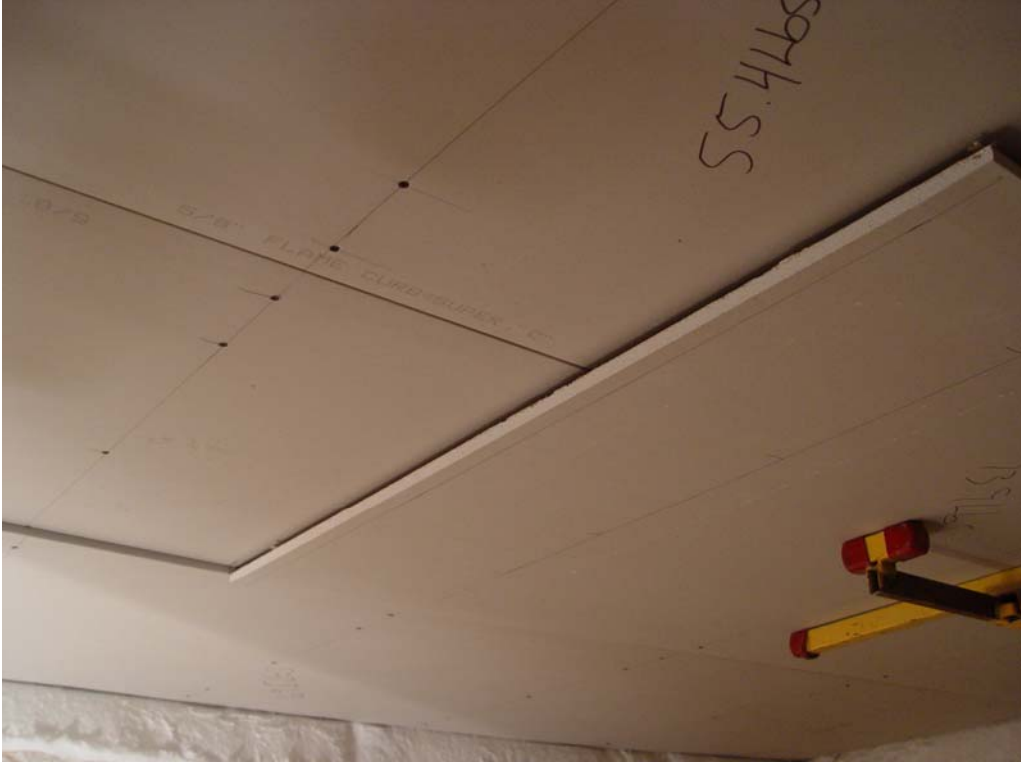
Application of Face Layer

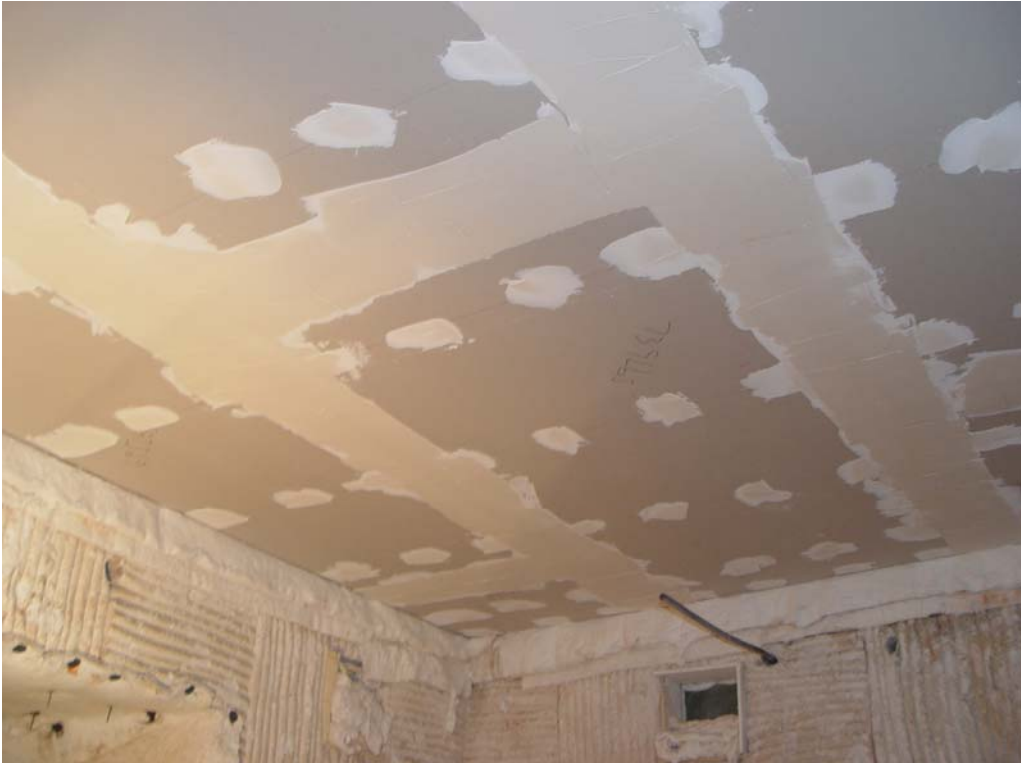
Finished Ceiling

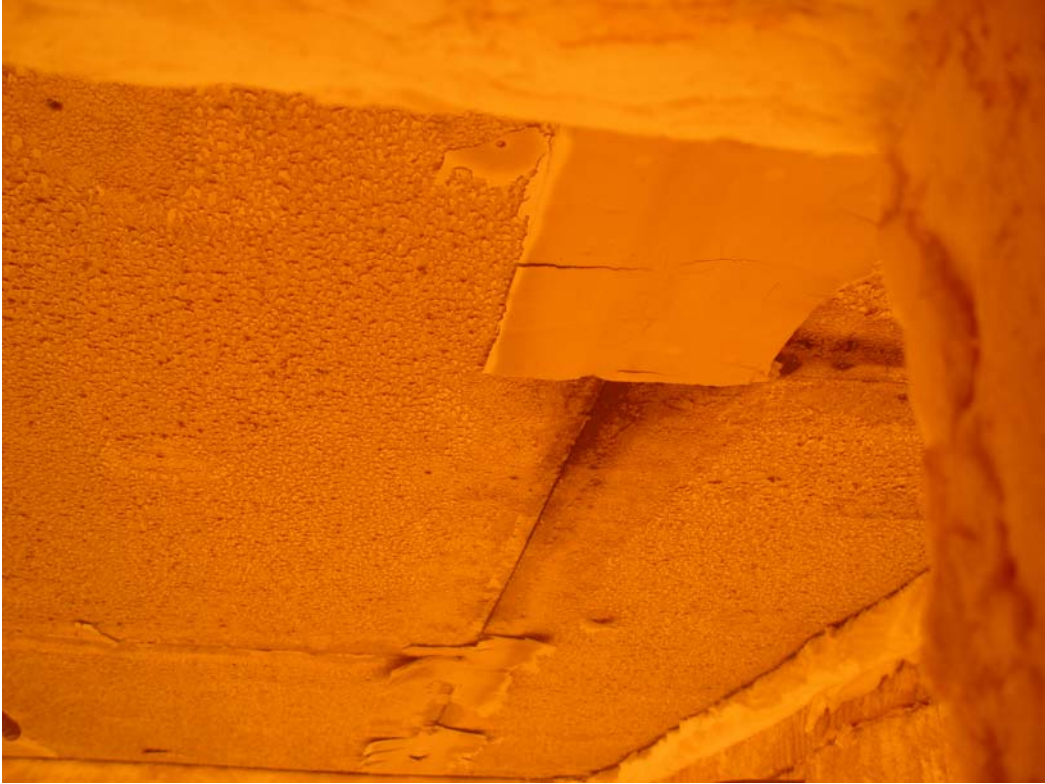
15 minutes- tape falling from E-W joint at N end of furnace

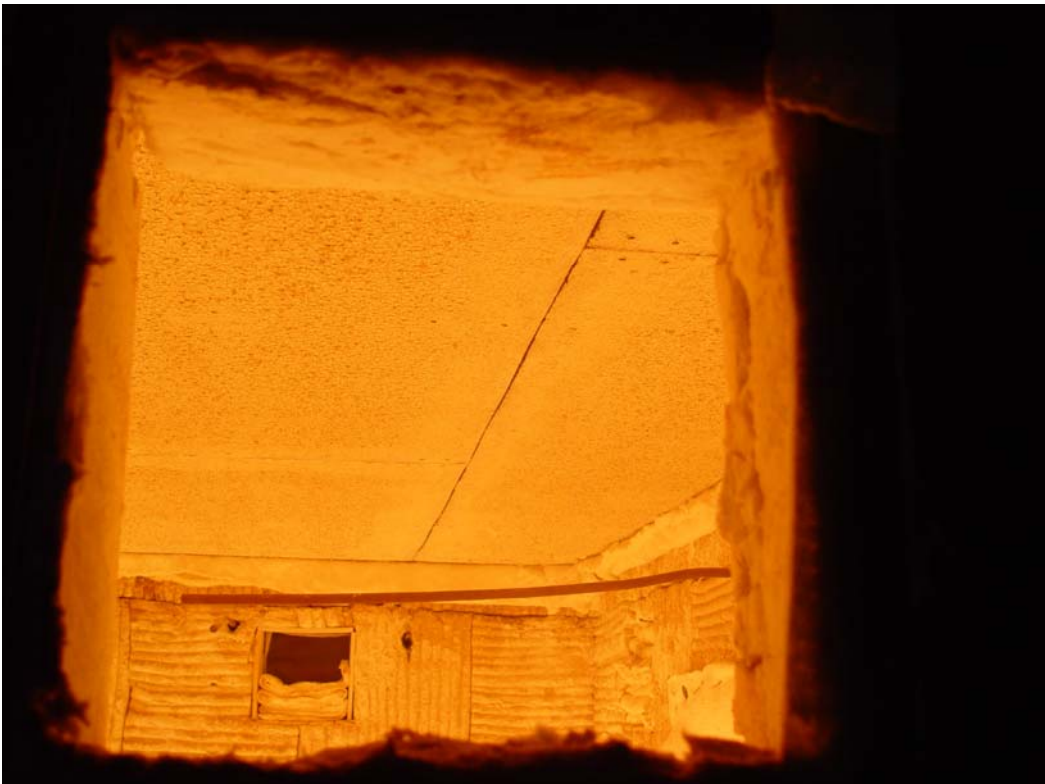
30 minutes: E-W joint at N end of furnace

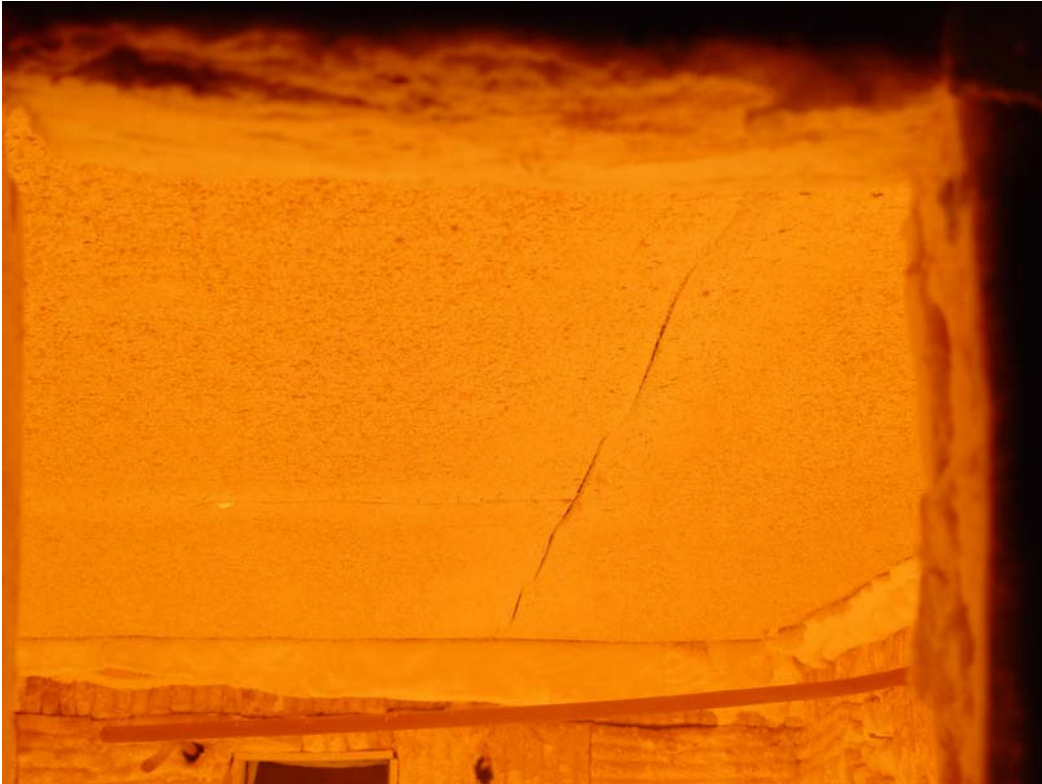
65 minutes: E-W joint at N end of furnace

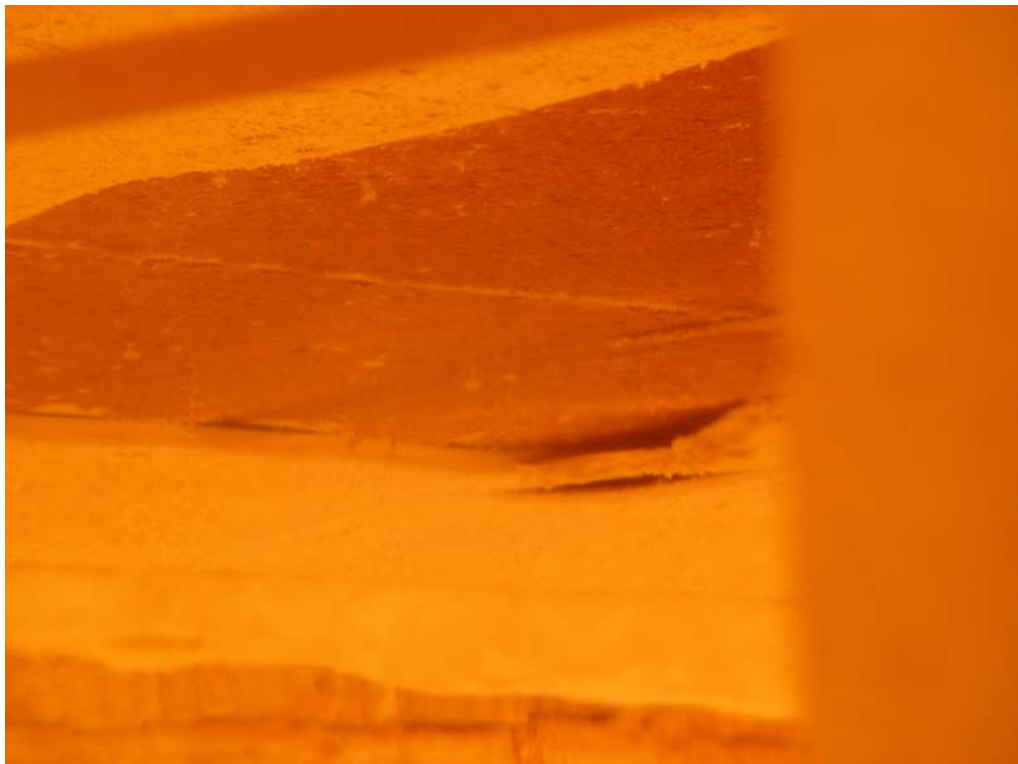
1 hour, 9 minutes: face layer falloff exposes base layer

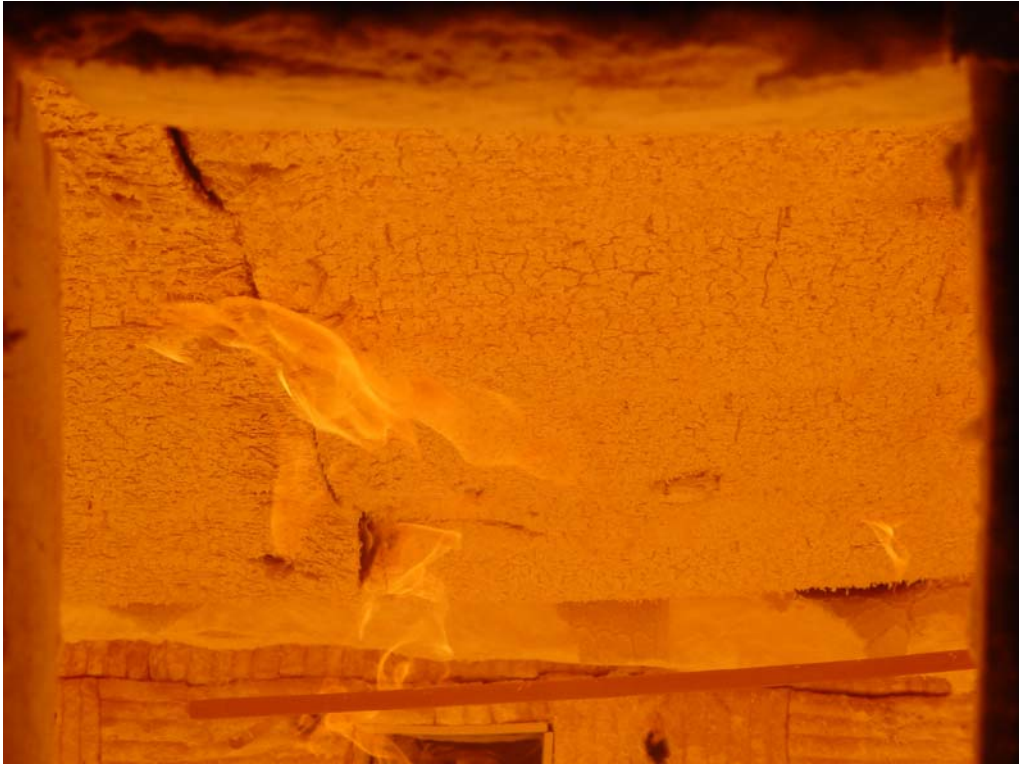
1 hour, 20 minutes: immediately prior to test termination

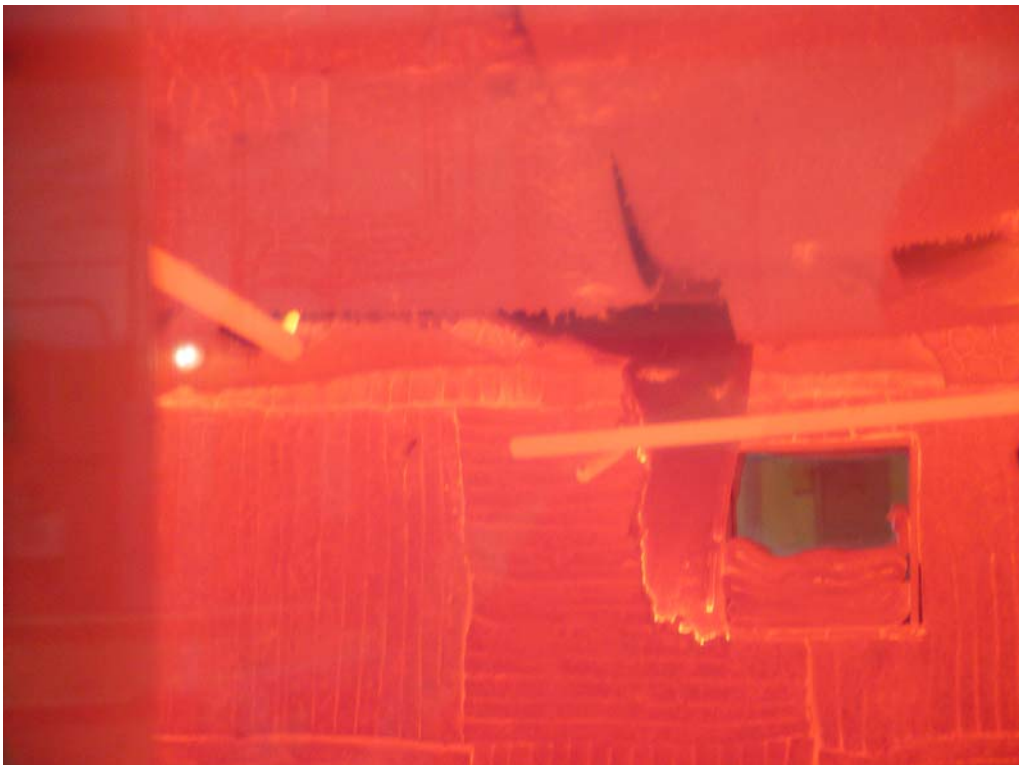
Immediately after test termination

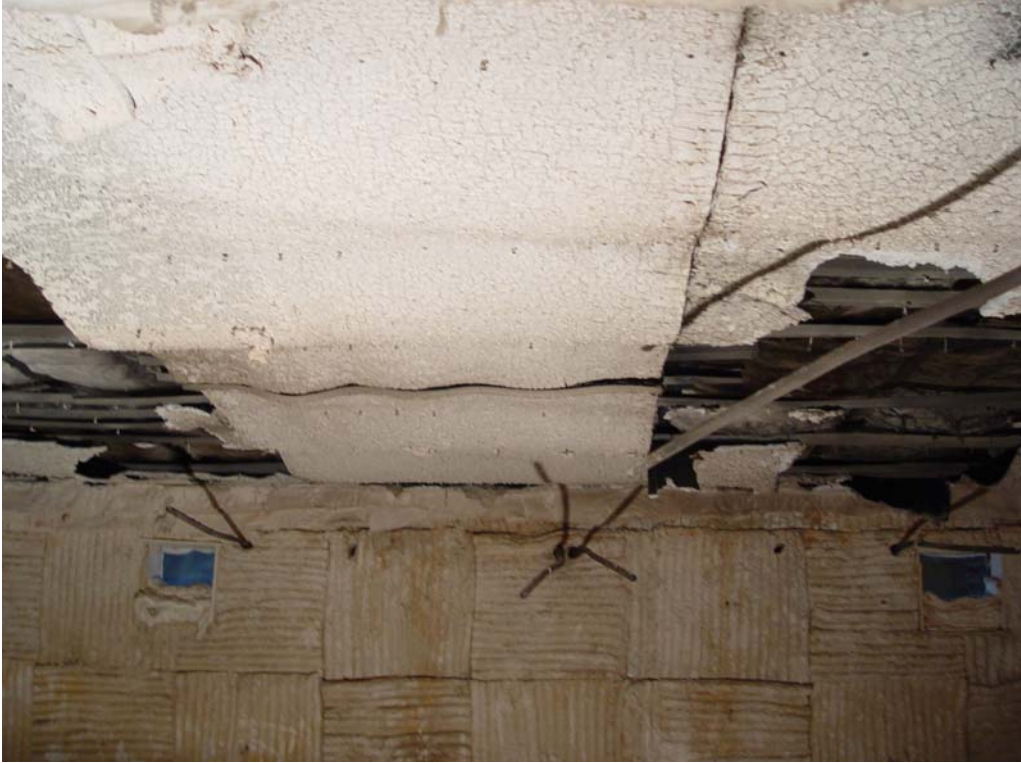
Post test: center section of ceiling
