Western Fire Center, Inc.

Fire Resistance Testing of a
Floor/Ceiling Assembly in
Accordance with ASTM E119-
05a/UL 263: *Fire Tests of
Building Construction and
Materials*

PAC International, Inc.
7310 Smoke Ranch Road, Suite E
Las Vegas, Nevada 89128

WFCi Report #07083

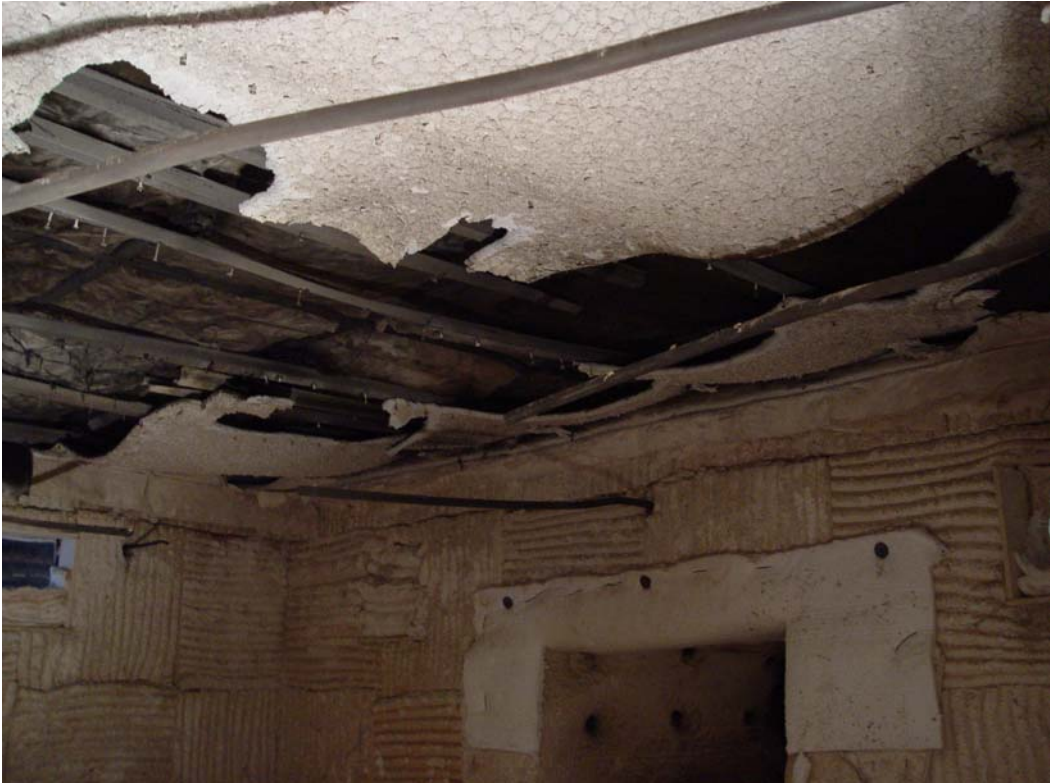
NW quarter section

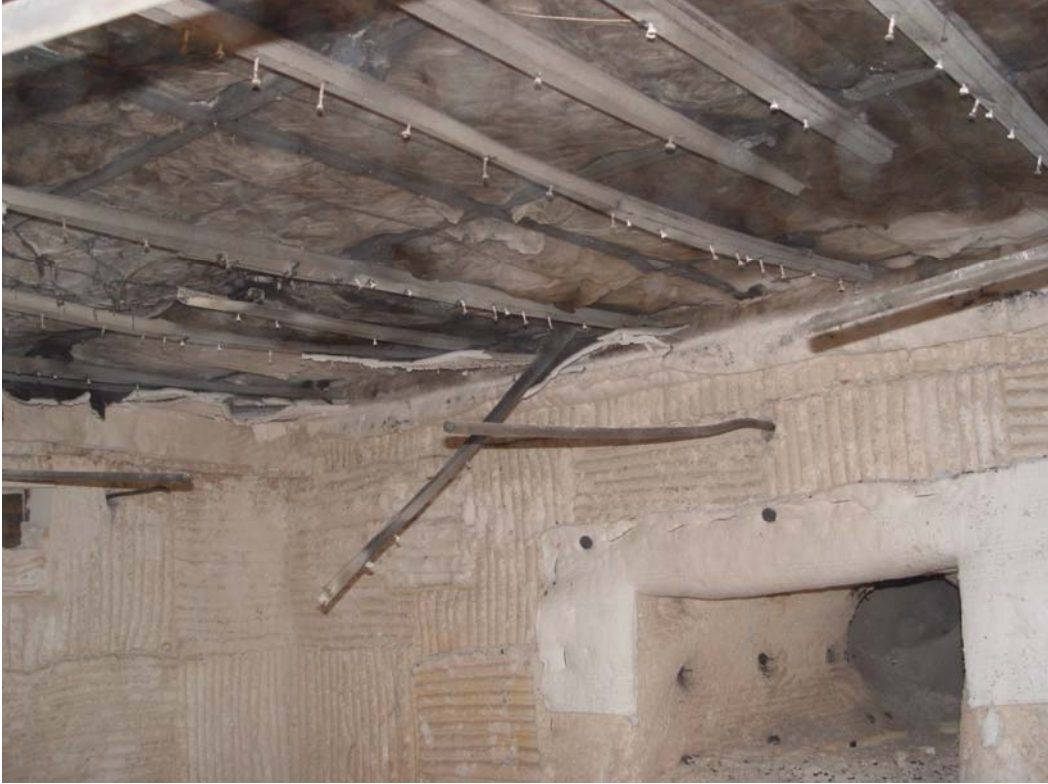
NW qtr section with furring channel and insulation exposed

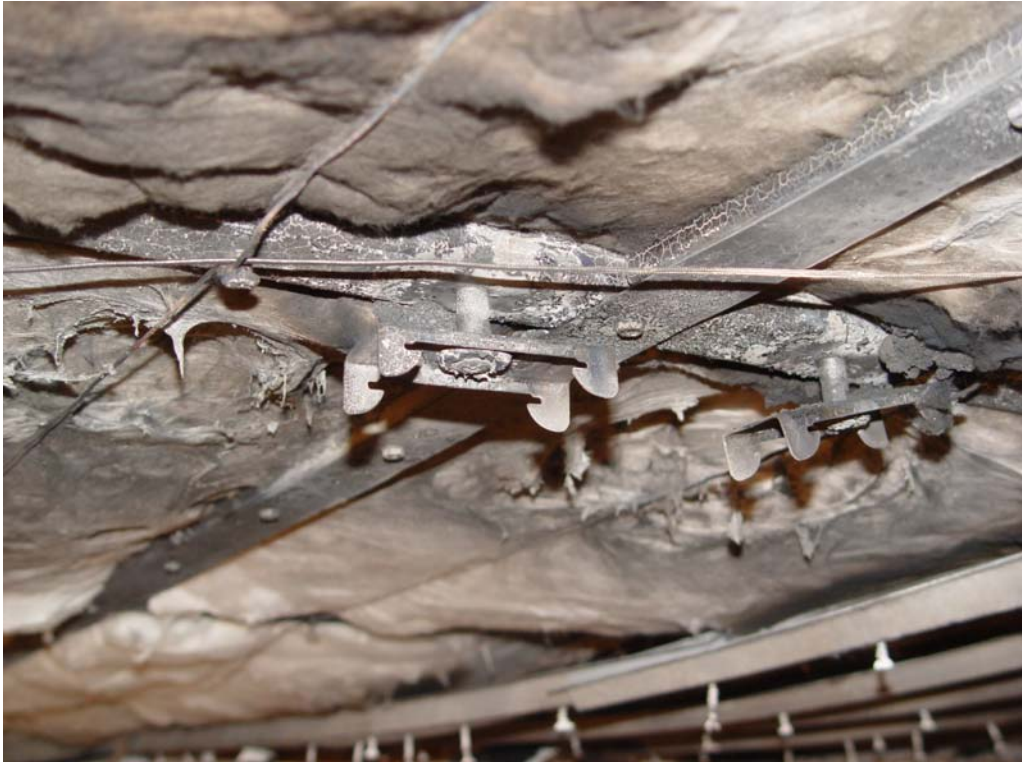
RSIC-1 clips with channel removed
